IN THE COURT OF APPEALS
OF THE STATE OF NEW MEXICO

HYUNDAI MOTOR COMPANY, HYUNDAI MOTOR
AMERICA, and BORMAN MOTOR COMPANY,

APPELLANTS' BRIEF IN CHIEF

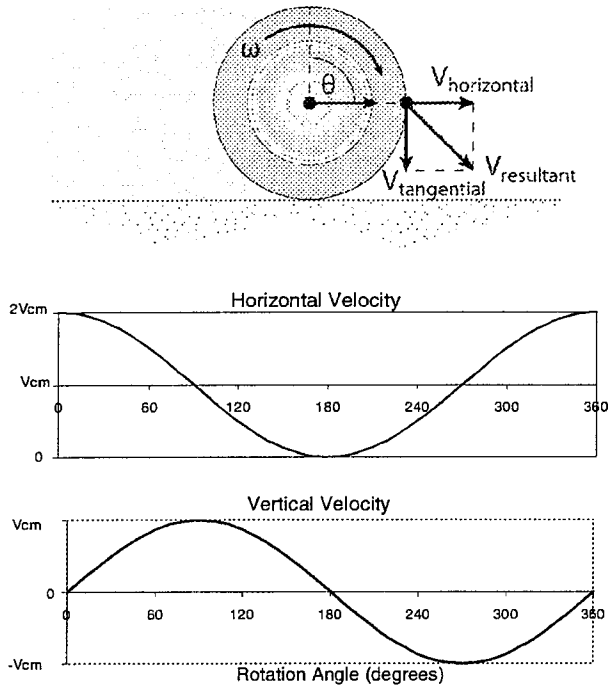
where ω is the rotation rate in radians per second, v is the velocity in meters per second, and r is the radius in meters. For our example, ω equates to about 12.5 radians per second or nearly 2 revolutions per second. If we were to calculate the velocity of a Point P on the edge of the wheel, again from a fixed reference frame, the observed instantaneous velocity would vary with time depending on where Point P happened to be. Its velocity is in the same direction as the center of mass at the top and in the opposite direction at the bottom. The resultant velocity would never be 48.3 kph in a horizontal direction. In fact, the velocity of Point P when it is right at the bottom would be exactly zero since the wheel is not slipping or moving against the surface. The velocity of P reaches a maximum in the horizontal direction when P is at the top and the vector sum of the velocity is twice the velocity of the wheel's center of mass or about 96.6 kph. In accordance with the vector sum in the first equation, a point on the surface of the rolling wheel has a velocity that is the vector addition of the center of mass velocity and the tangential velocity. The tangential velocity has both magnitude and direction and while its magnitude remains constant (for a constant center of mass speed) the direction of the tangential velocity varies with time. The velocity of P for three distinct wheel orientations is shown in Figure 2. The velocity of P, in terms of its horizontal and vertical components, takes the form of trigonometric functions and is shown in Figure 3.

Figure 3: Horizontal and vertical velocity components of point P for one revolution.

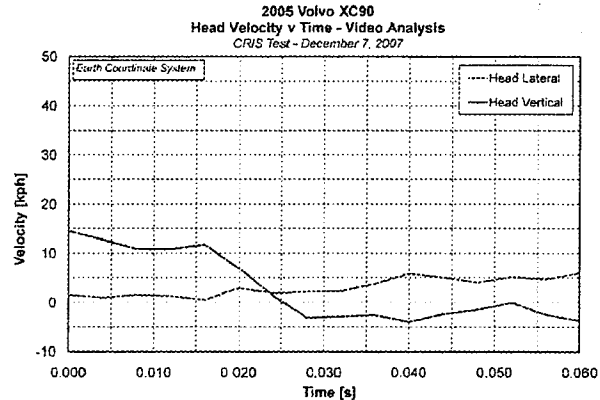
can be made in the earth-based reference frame for the vertical velocity profiles between the video analysis (Figure 24) and the ATD acceleration data (Figure 17). These comparisons validate the earlier analysis from an independent data set.

Figure 24: Component velocities of the ATD head in the earth-based reference system.

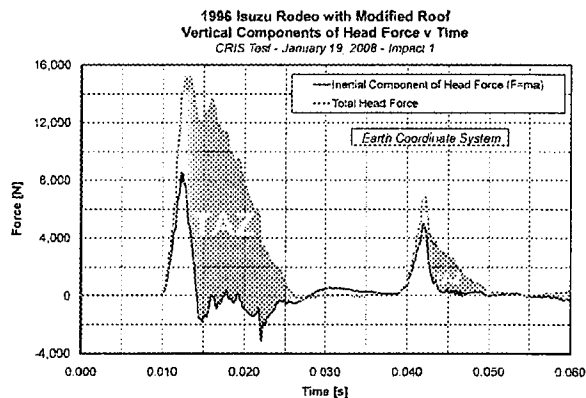
It is noteworthy to point out that the second head loading event seen in **Figure 27** is directly with the ground after the head continued passed the roof rail. The loading profile demonstrated similar head inertial and neck force characteristics to that seen in the preceding head contact with the vehicle structure just milliseconds earlier.

Figure 27: Vertical inertial and total head force during the first Rodeo CRIS impact.

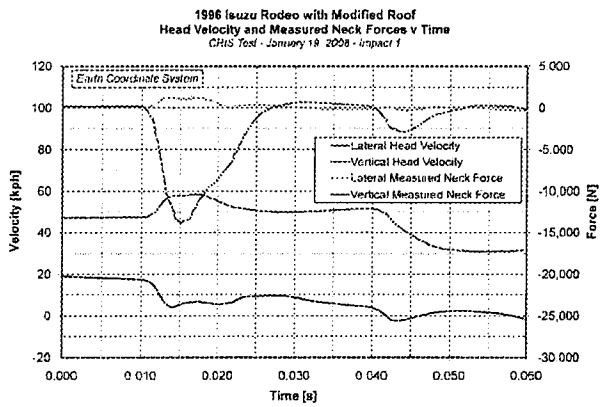
Figure 29: Measured neck loads and head velocities in the earth coordinate system.

The initial lateral and vertical head velocities from the plot in Figure 29 were 47 kph and 19 kph, respectively. A vector analysis, similar to that done for the XC90 impact, was performed for the first Rodeo impact and is presented in Figure 30. Comparison of the vector analysis and the electronic data again demonstrates reasonable agreement.

The screen capture from the onboard rear high-speed video camera in the Rodeo test (Figure 31) shows the orientation of the ATD with the interior of the left roof rail. The head was not in contact with the roof rail, which is not entirely clear in this image, but is known based on the zero compressive neck load shown in Figure 29.

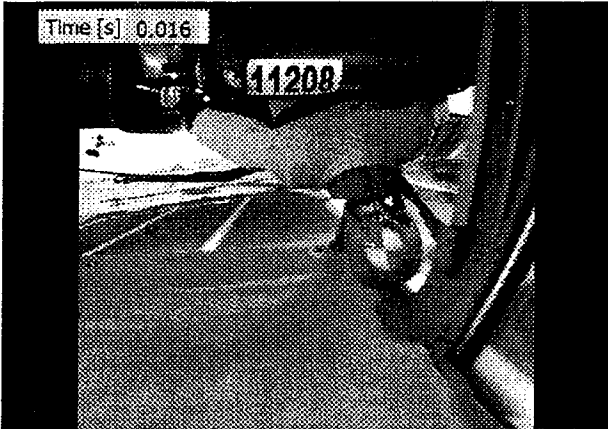
The peak measured compressive neck load occurred at 15.2 ms and the nearest frame in the high-speed video to this peak was at 16 ms, which is shown in Figure 32. The physical loading of the neck in compression is clearly observed by comparing the aluminum neck rings at 16 ms versus the unloaded neck at 0 ms. Interestingly, both the XC90 and the Rodeo had ATD head clearance at vehicle contact with the ground. The peak measured neck load occurred earlier in the Rodeo test (15.2 ms) than in the XC90 test (19.3 ms), which is attributable to two things in the Rodeo test: (1) the head was closer to the roof rail and (2) a higher vertical velocity based on the initial conditions. An attempt to apportion the role played by these factors in the timing of the neck load has not been made.

Figure 32: Screen capture of the onboard high-speed video of the driver ATD in the Rodeo CRIS test near peak measured compressive neck load.

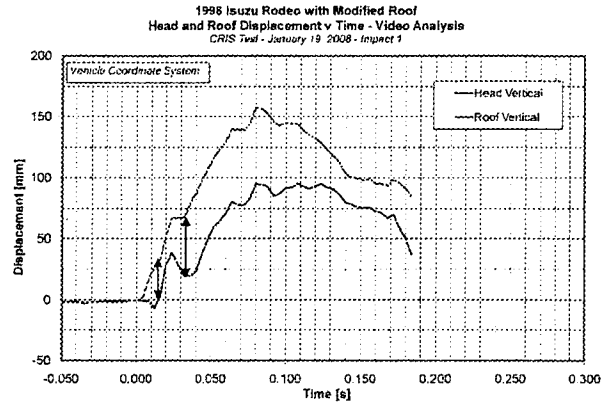
Figure 34: Roof and head displacement calculated from the on-board high-speed video camera. Arrows indicate timing of head-to-roof rail and head-to-ground contact.

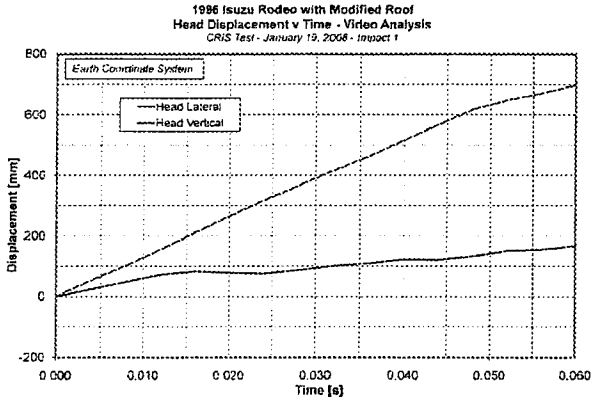
Figure 36: Component displacements of the ATD head in the earth-based reference system.

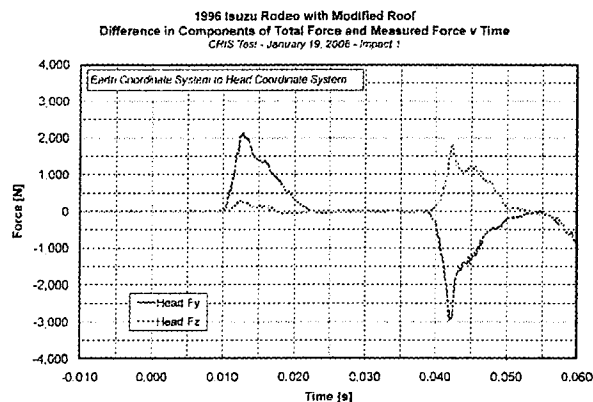
Figure 40: Difference between detailed analyses for the Rodeo in the earth reference frame versus the head reference frame.
